# The Use of ASTM A1010 – a Dual-phase Martensitic/Ferritic Stainless Steel for Bridges in the United States

# Matthew H. Hebdon<sup>a</sup> and Jason T. Provines<sup>b</sup>

Virginia Tech, Blacksburg, VA, US<sup>(a)</sup> Virginia Transportation Research Council, Charlottesville, VA, US<sup>(b)</sup>

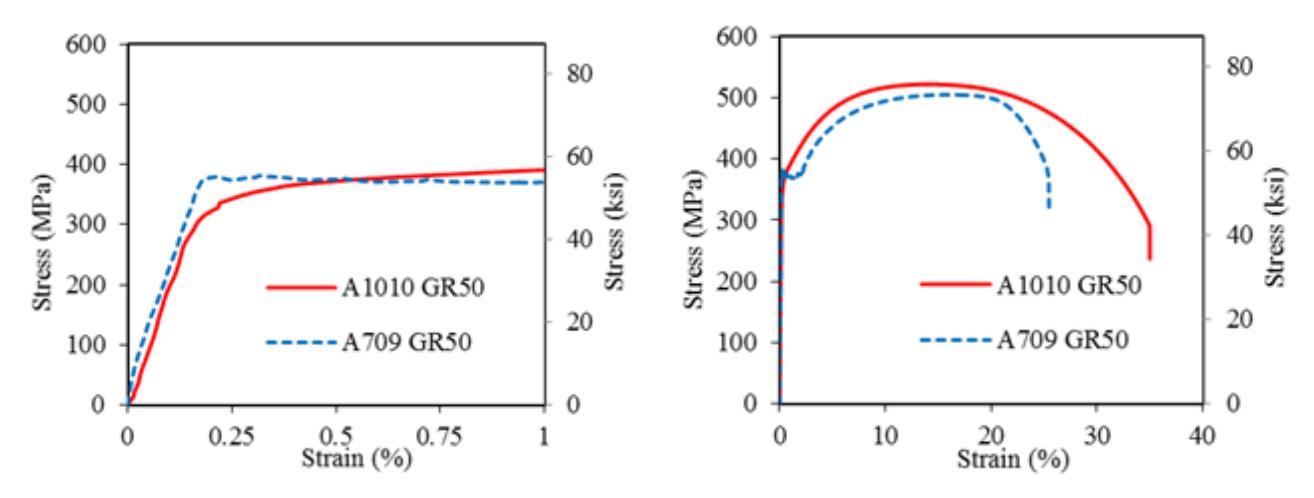
Fig. 1 Stress-strain comparison of ASTM A1010 Gr50 steel and ASTM A709 Gr50 steel to strains of 1% (left) and 40% (right)

The stress vs. strain behaviour of A1010 Grade 50 has some notable differences when compared to A709 Grade 50 steel. The Virginia Transportation Research Council (VTRC) at the Virginia Department of Transportation (VDOT) recently performed tensile tests on A1010 coupons; the test data were then compared to a typical A709 steel tensile test. Both tests were performed on 25 mm (0.5 in) thick specimens. The test results of the two types of steel are shown in Fig. 1. For small strains (less than 1%), the A709 steel exhibited linear elastic behaviour up to its yield stress before undergoing strain hardening. In comparison, the A1010 steel also demonstrated a linear elastic behaviour, but had a more rounded response with no clear yield point. The A1010 steel also did not display a flat yield plateau as the A709 steel does. It was observed that the A1010 steel experienced a significantly greater amount of ductility of approximately 35% strain prior to fracture, while the A709 steel fractured at approximately 25% strain.

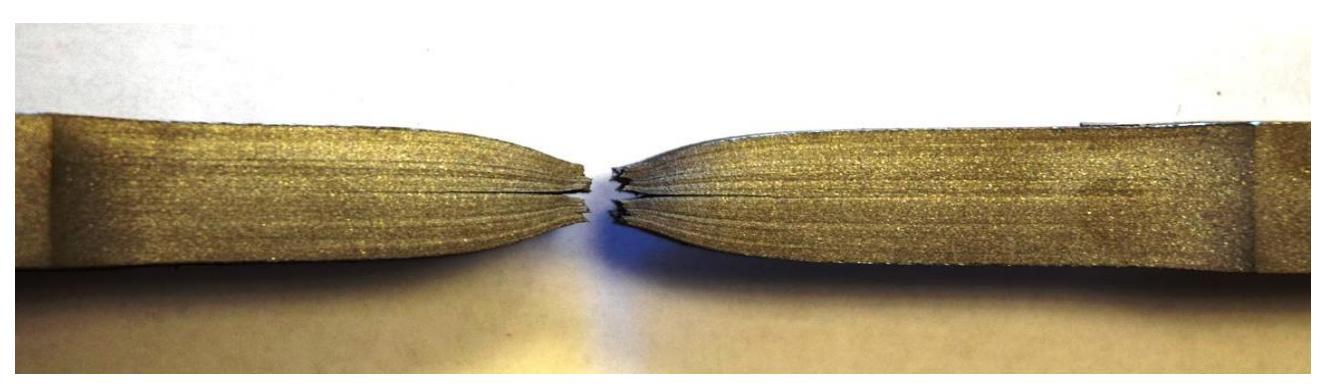
Fig. 2 Delamination fracture present within gauge length of ASTM A1010 tensile test specimen

Another important observation from the A1010 tensile tests was the presence of a delamination within the gauge length of the tensile specimen as shown in Fig. 2. Similar delaminations were observed on tensile tests of welded A1010 samples conducted by the Oregon Department of Transportation (ODOT) (Seradj, 2010). Although this delamination behaviour has not been observed in typical A709 steels, all of the A1010 tensile tests conducted at VTRC have met or exceeded the minimum specified mechanical property values of the ASTM A1010 specification.

An initial set of PQRs for a single bevel groove weld was completed using conditions recommended by Kelley (2003) including an interpass temperature of 107°C (225°F) and an ER309L weld metal. Pressurized air was directed at the bottom of the weld joint to decrease the time required to meet the interpass temperature and reduce the overall weld time. It was noted that the E309L consumable resulted in a significant amount of weld distortion and it was recommended that measures be taken during fabrication to limit such distortion in welded joints. All tested specimens met the PQR requirements of D1.5 and so three additional sets of specimens were created using interpass temperatures of 149°C (300°F), 204°C (400°F), and 232°C (450°F). At each test temperature, all required PQR tests were satisfactory; the required weld tests included tensile coupons on all weld-metal, CVN tests, macroetching, radiographic inspection, reduced section tensile coupons, and side bend tests. While the tests were all satisfactory for all three additional interpass temperatures, the tensile tests were observed to have a delamination-like surface at the point of

fracture similar to the one shown in Fig. 2. A resulting straight beam ultrasonic test was conducted by the fabricator on theses specimens, but did not reveal any lamellar tearing in the material.

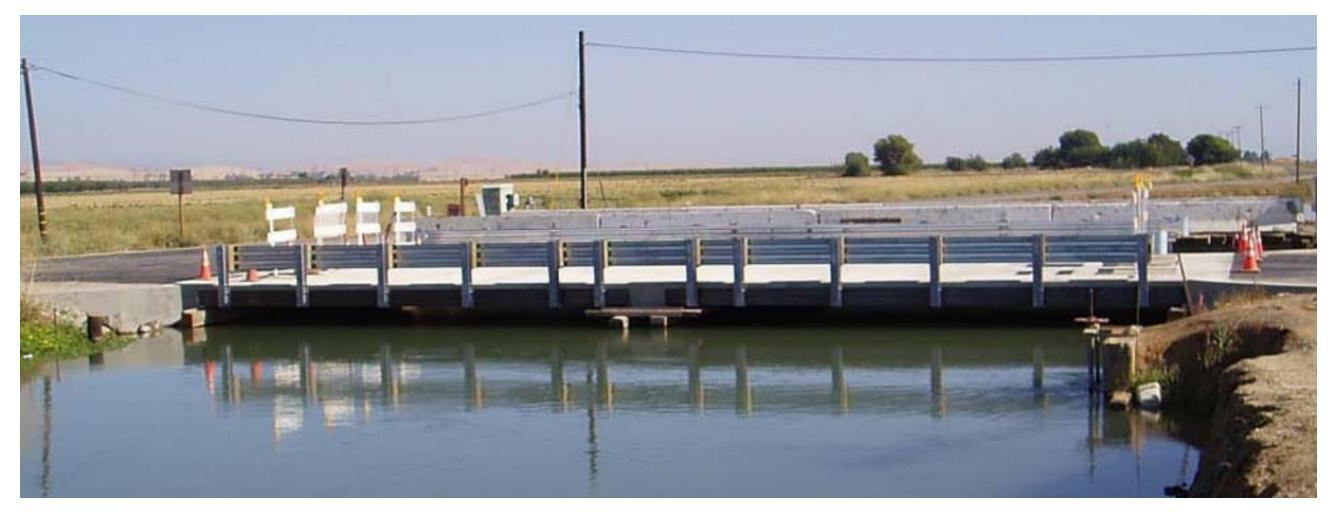
Fig. 3 Low clearance under the Fairview Road Bridge, Colusa County, CA (F. Fletcher, 2011)

In 2004 the first vehicular bridge to use A1010 steel in the U.S. was constructed to carry Fairview Road over the Glenn-Colusa Main Canal in Colusa County, California. The approach roadway required a bridge with a clearance of approximately 0.3 m (1 ft) at high water events, as shown in Fig. 3. Since access below the bridge was limited due to the clearance, a bridge with minimal maintenance was desired. Colusa County engineers proposed the use of A1010 to the California Department of Transportation (Caltrans) as part of the FHWA Innovative Bridge Research and Construction (IBRC) program (Fletcher et al., 2005). Multi-cell bridge girders (MCBGs), composed of shallow steel modular c-shaped units, were selected for the structural system to reduce the height of the structure and significantly reduce the construction time. It was reported that the selection of A1010 for the material allowed the thickness (and weight) of the structural steel plates used to fabricate the modular units to be reduced by 50% due to the elimination of additional steel thickness for sacrificial corrosion resistance. A1010 was an available steel product in the US at that time, but until this point had not been used for bridge applications (Fletcher, 2011).

The Fairview bridge was constructed with two 10.7 m (35 ft) spans and a total width of 9.6 m (31.5 ft). The MCBGs were fabricated using 4 mm (0.16 in) thick A1010 Grade 50 steel plate which was formed into C-shaped units by press

brakes (Fletcher et al., 2005). The units were then longitudinally welded together using E309L consumable wire into modules of eight units for erection. Diaphragms and other attachments for rail post connections were also welded to the bridge modules. All plates were prepared using a water-jet to cut the material. The shear studs were of a low carbon steel, but were welded onto the top of the A1010 modules without any difficulty.

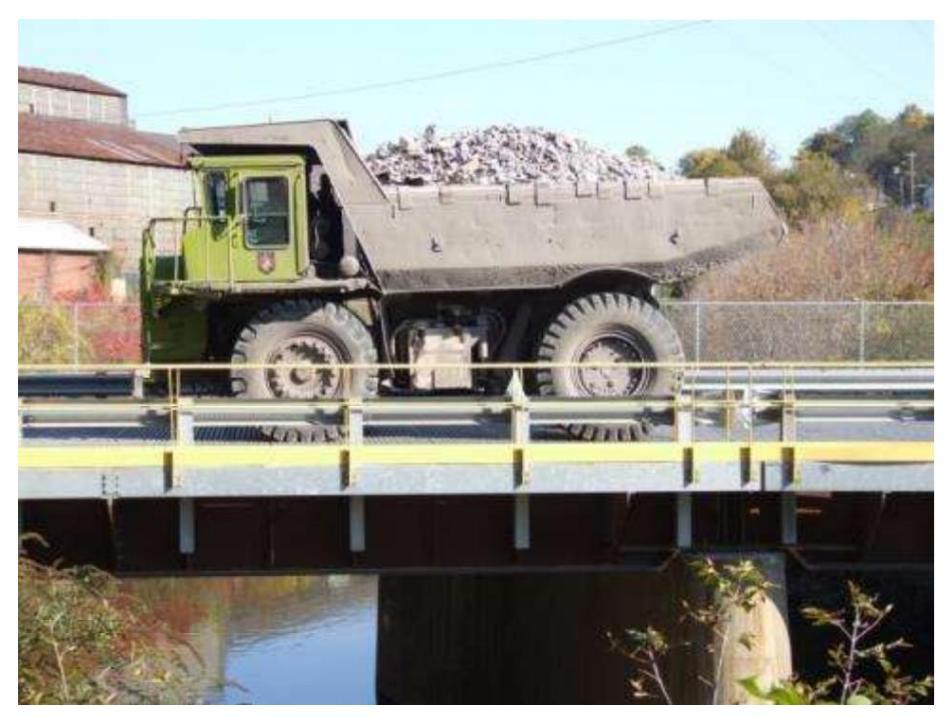
Fig. 4 Heavy truck loads on ArcelorMittal Bridge, Coatesville, PA

In 2012 ArcelorMittal, the only producer of A1010 in the US, funded the construction of a private two-span A1010 plate girder bridge over the West Branch of the Brandywine Creek at their Coatesville, Pennsylvania steel mill (ArcelorMittal, 2015). A1010 steel was used because the bridge was located adjacent to the mill, an industrially corrosive environment, with a high time-of-wetness. Additionally, ArcelorMittal wanted to demonstrate the corrosion resistance in an environment in which the bridge was subjected to a significant amount of heavy truck traffic, adjacent to the mill. An example of the heavy truck loads crossing the bridge is shown in Fig. 4.

The ArcelorMittal bridge was constructed with six girder lines consisting of welded plate girders with intermediate transverse stiffeners (ArcelorMittal, 2013). The bridge consists of two 14.9 m (49 ft) spans. Plate thicknesses ranging from 9.5 mm (0.375 in) to 38.1 mm (1.5 in) were used in the plate girder fabrication. Welds were performed using an E309L consumable for all A1010 material.

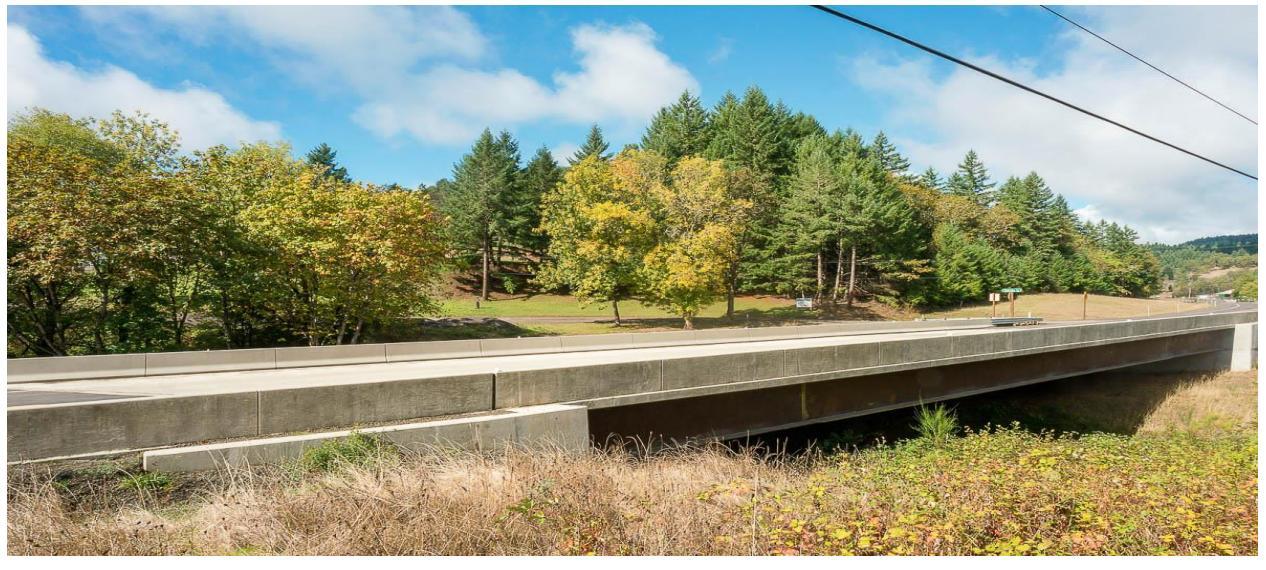
#### Fig. 5 Dodge Canyon Bridge, OR (NSBA, 2014)

Champions of A1010 steel within the Oregon Department of Transportation (ODOT) performed several small experimental programs to better understand the material properties and fabrication needs of A1010 steel. They successfully promoted its corrosion resistance and obtained state and federal grants supporting the new material for two recently constructed bridges. ODOT's first A1010 bridge was constructed on Route 138 over Dodge Creek, near Sutherlin, Oregon in 2012. The single-span 40.4 m (132.5 ft) bridge was constructed with four plate girders, and a cast-in-place concrete deck having a width of 13 m (42.6 ft). A photograph of the bridge is shown in Fig. 5 (NSBA, 2014). This bridge had a high time-of-wetness and was chosen by ODOT as a trial location for their first A1010 venture. Due to limited material availability, weathering steel cross-frames with weathering steel bolts were used.

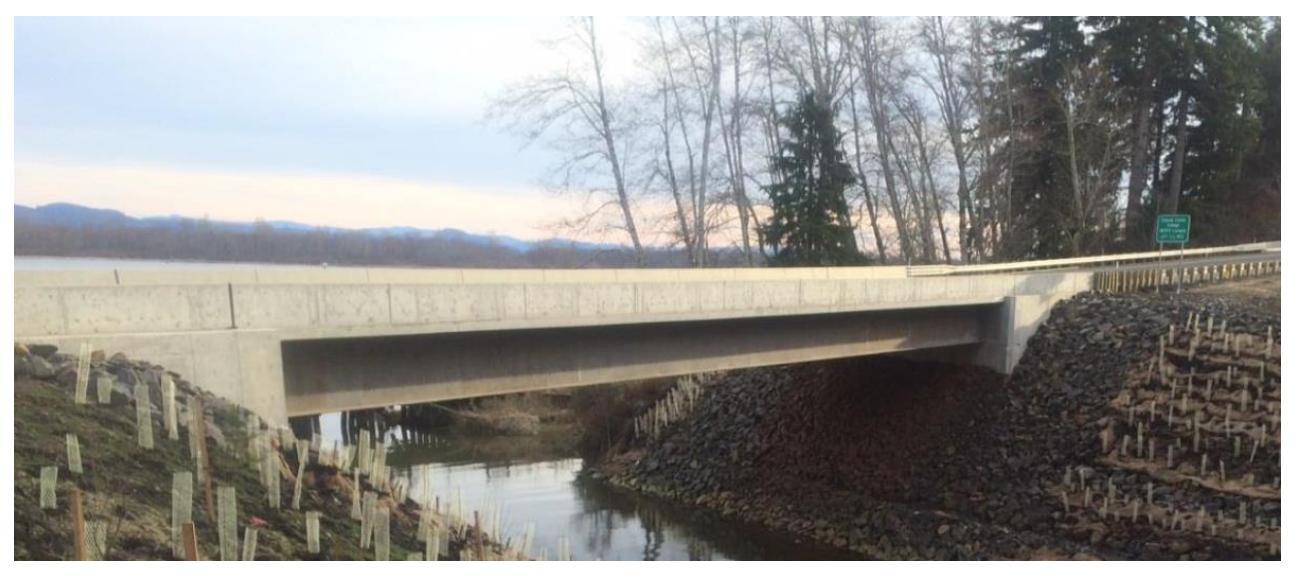
Fig. 6 Mill Creek Bridge, OR (Seradj, 2015)

One year later, in 2013, a similar single span 37.5 m (123 ft) A1010 plate girder bridge was completed over Mill Creek on Route 30 near Astoria, Oregon, as shown in Fig. 6 (Seradj, 2015). This bridge crosses the Mill Creek as it empties into the Columbia River Estuary, and is therefore in a corrosive marine environment making it an excellent location for additional corrosion resistance. It has four plate girders, and a total width of 13 m (42.6 ft). All A1010 material was cut using a plasma cutter and welded with ER309L welding consumables. Stainless steel fastener assemblies were specified for use during erection.

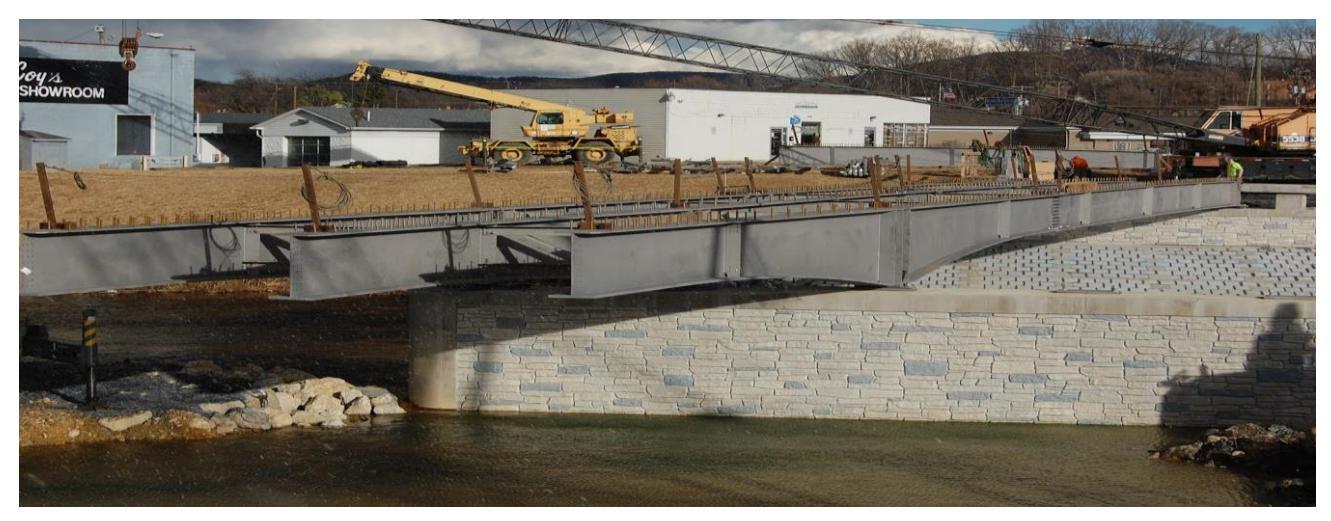
Fig. 7 Route 340 Bridge Construction, VA

In 2017, VDOT finished construction of the latest A1010 bridge constructed in the US. The bridge carries Route 340 over the South River in Waynesboro, Virginia. This project was the first time that A1010 steel had been used in a haunched plate girder bridge (see Fig. 7). It was also the first time that a US bridge design specified stainless steel for all secondary members and fasteners. Since A1010 angles were not available at the time of construction, bent A1010 plates were specified to be used in the fabrication of all cross-frames. Additionally, stainless steel fastener assemblies were specified throughout the bridge. A1010 material was selected for this location due to its proximity to an industrial area resulting in a corrosive environment, as well as the possibility of low water clearance over the South River.

The objective of this project is to document the construction of the U.S. Route 340 Bridge in Waynesboro, VA. This bridge was constructed using A1010 steel girders, cross-frames, and stainless-steel fastener assemblies. Documentation includes the mill process and rolling of the A1010 steel plate as well as the design, fabrication, and erection of the Route 340 bridge. Each step of the process includes a documented comparison to traditional materials and fabrication, such as for painted, weathering, and galvanized steel. A cost analysis will be performed to assess the associated cost

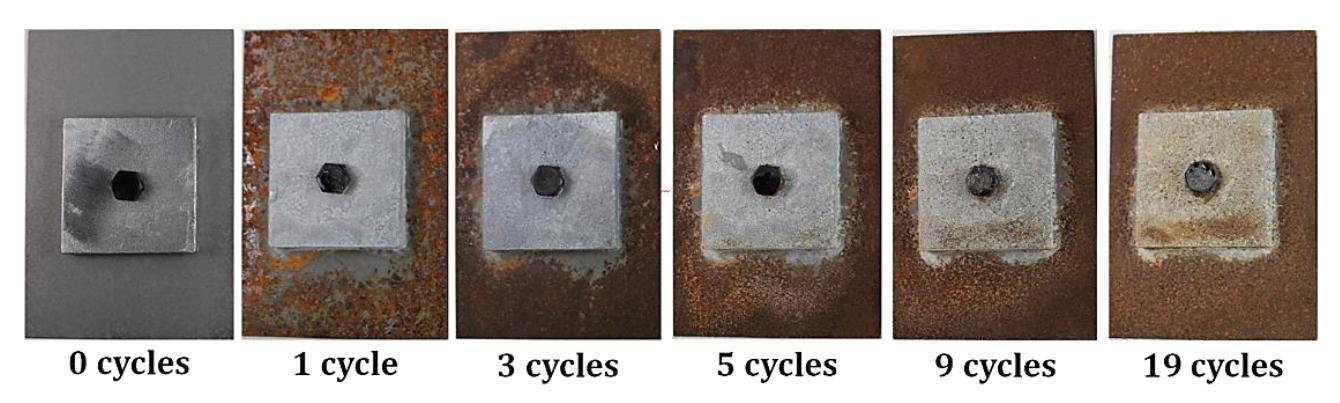
Fig. 8 Migration of zinc from HDG specimens

The results of the first phase of corrosion testing indicated that the A709 Gr50 HDG plate had the best outcome when attached to the A1010 steel plate specimens. Table 4 shows the relationship between the A1010 steel plates and the dissimilar steel plates. An increasing rate of corrosion was observed for all A1010 plates when connected to dissimilar

plates. Both the Gr50 and the Gr50W had similar results from the aggressive corrosive environment that prevented creation of a passive surface layer. Crevice corrosion was observed on both the Gr50 and Gr50W specimens where the edges of the smaller dissimilar plate came into contact with the A1010 plate. The cyclic nature of crevice corrosion appeared to be a contributing factor to the increase in corrosion rate of the A1010 plate. The HDG assemblies were observed to experience migration of the zinc to the A1010 plate, as shown in Fig. 8. Additionally, the assemblies with HDG plates were observed to have a linear rate of corrosion until the zinc coating was depleted, at which point the rate of corrosion dramatically increased to a linear rate similar to the A709 Gr50. However, while there was a large increase in the rate of corrosion for the HDG specimens, the actual corrosion loss was much lower than both the Gr50 and Gr50W specimens. No clear change in corrosion rate was found for any of the specimens when the dissimilar plate sizes were varied.
